United States  
Circuit Court of Appeals  
For the Ninth Circuit.

UNITED STATES OF AMERICA,  
Appellant,

J. LESLIE MORRIS COMPANY, INC., a cor-  
poration,  
Appellee.

Transcript of Record  
(Plaintiff's Exhibits 1 to 32)

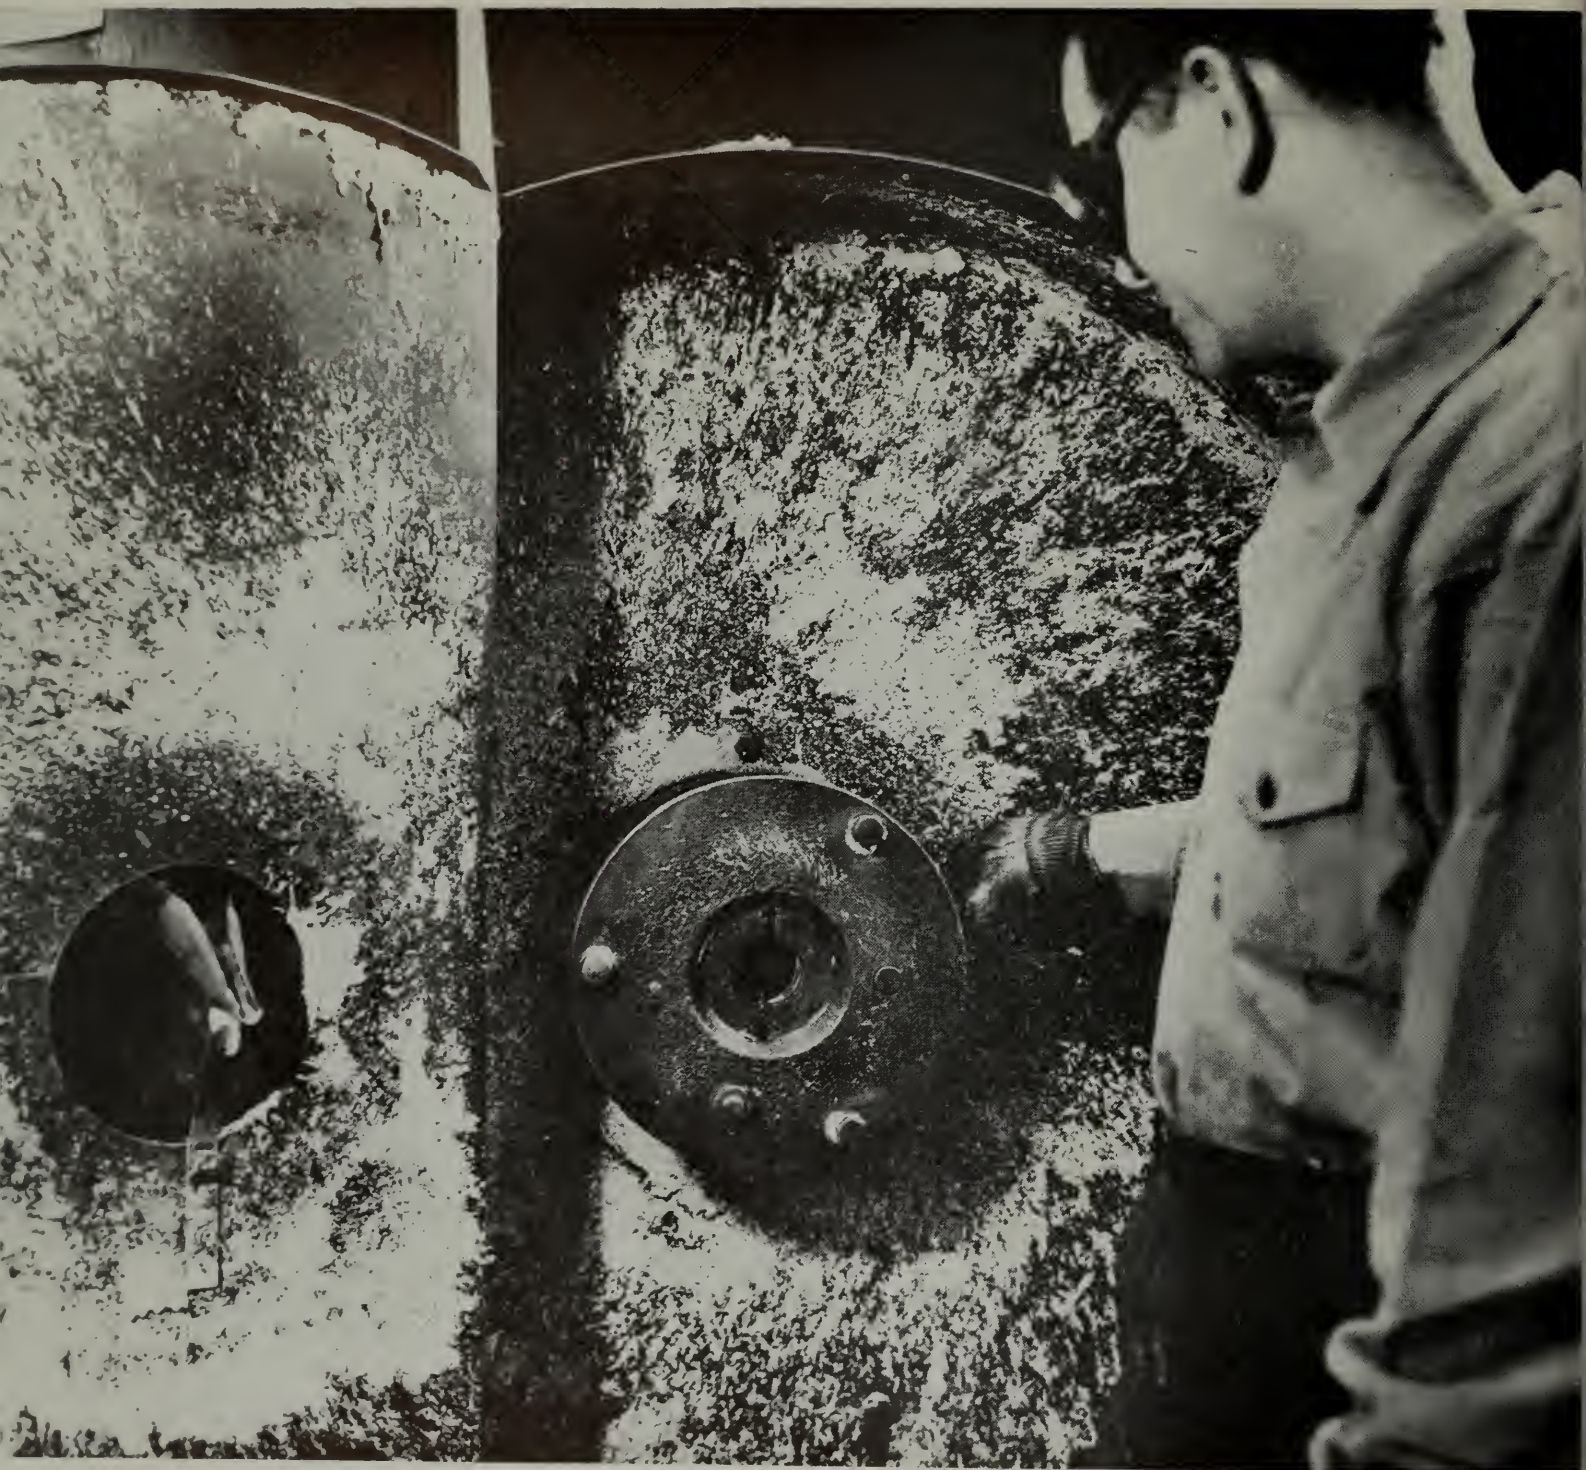
PLAINTIFF'S EXHIBIT No. 10

Any oil holes appearing in various places on the cap or the bearing end of the rod (varying with the type of rod) are plugged with asbestos wicking as shown above. In some instances small cork stoppers are used and even toothpicks on the smaller rods. This caulking process prevents the babbitt from plugging up the oil holes.

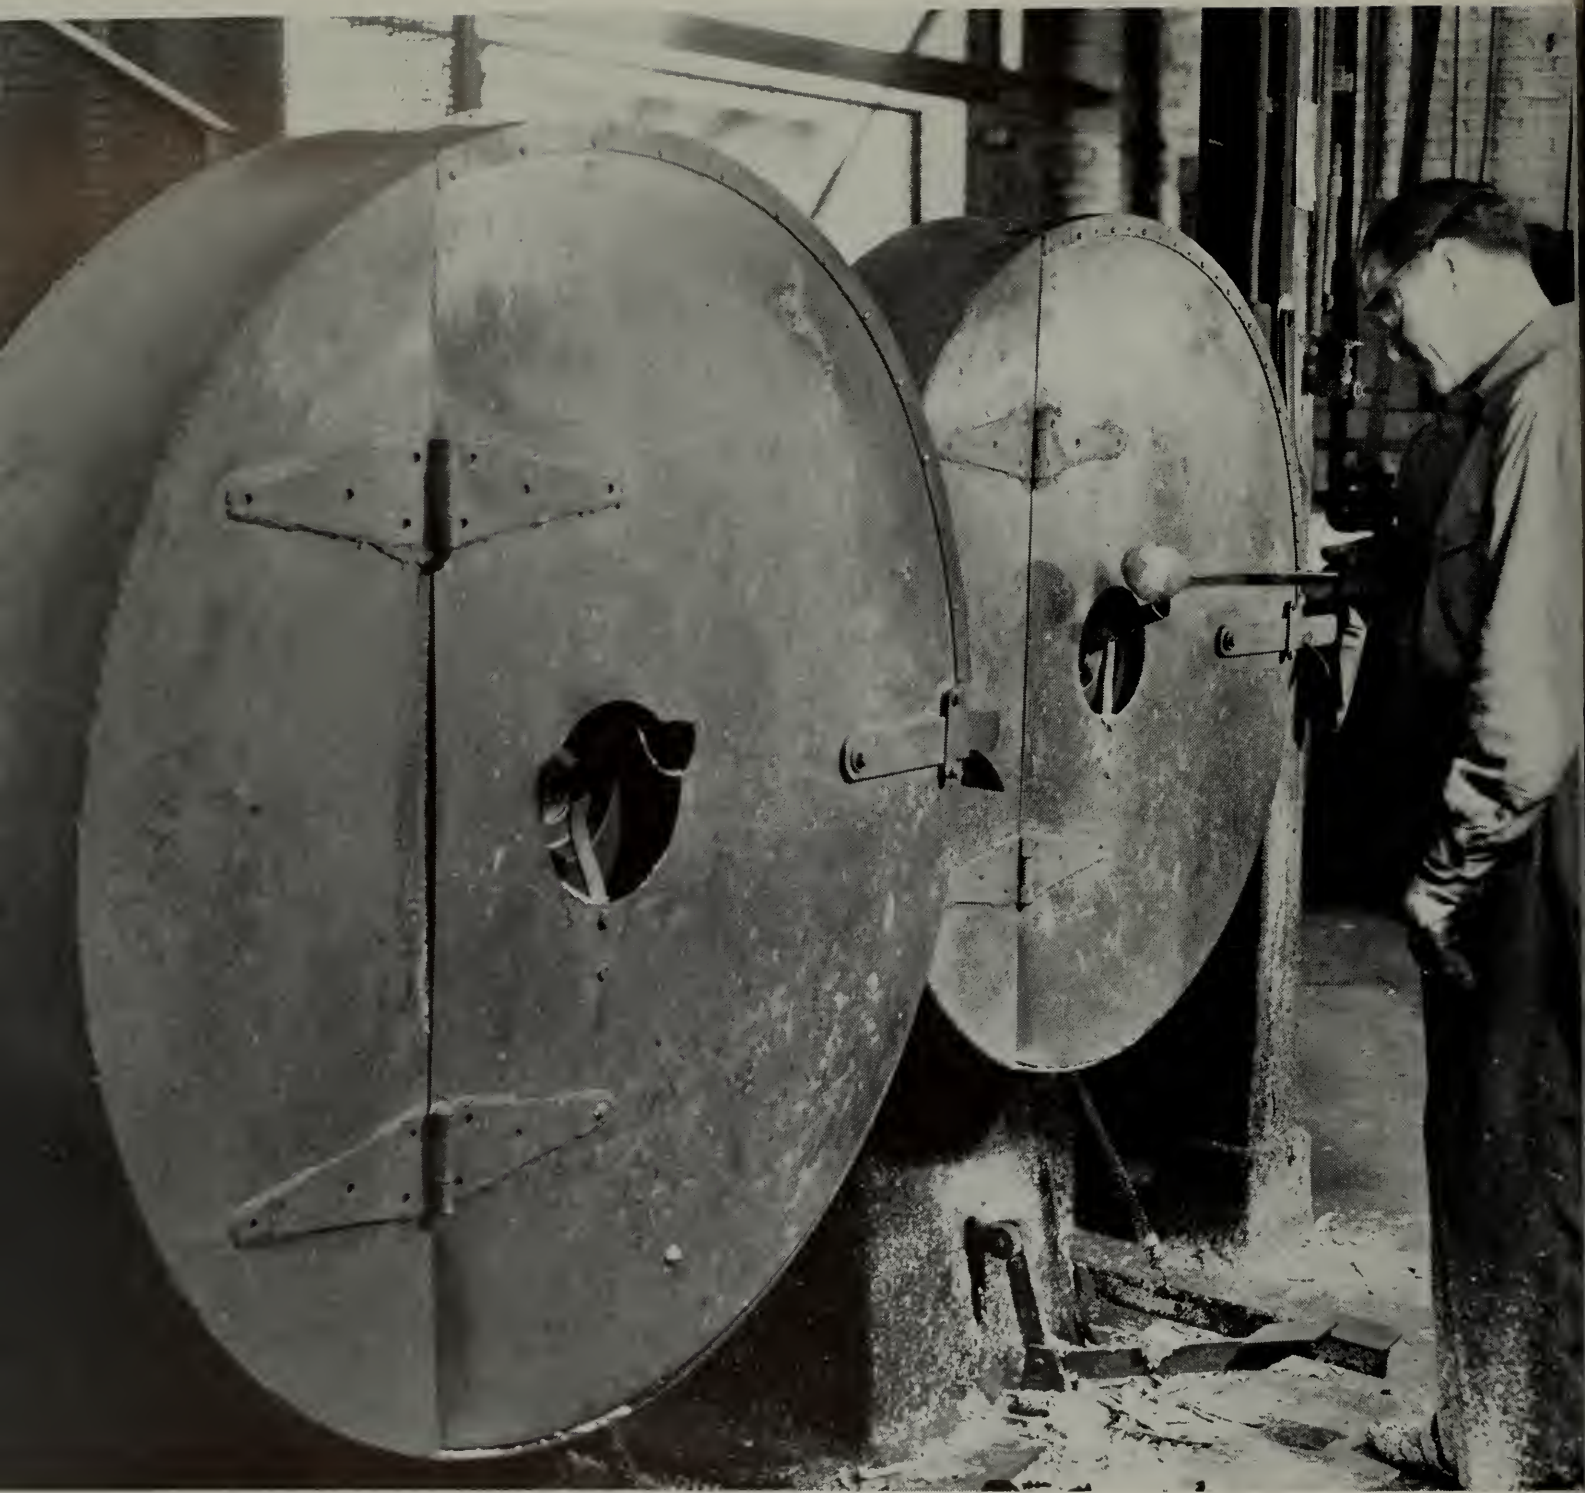
PLAINTIFF'S EXHIBIT No. 11

The rods are then taken to the centrifugal casting machines which were built by Plaintiff corporation for its own use. There are two of these machines because it takes the babbitt about fifteen seconds to cast and thus one operator can run the two machines. Each of these centrifugal casting machines consists of a revolving shaft on which is mounted a mold holder shown above. This mold holder is opened by means of a foot lever and the bearing end of the rod is placed between the molds which cup over each side of the bearing end. The illustration above shows the operator with his right hand covering the shank end of the rod with the bearing end in between the open mold. When the foot lever is released the outer part of the mold seen in the picture snaps back against the bearing end of the rod holding the rod securely so that it makes a perpendicular axis to the shaft on which the mold holder is mounted.

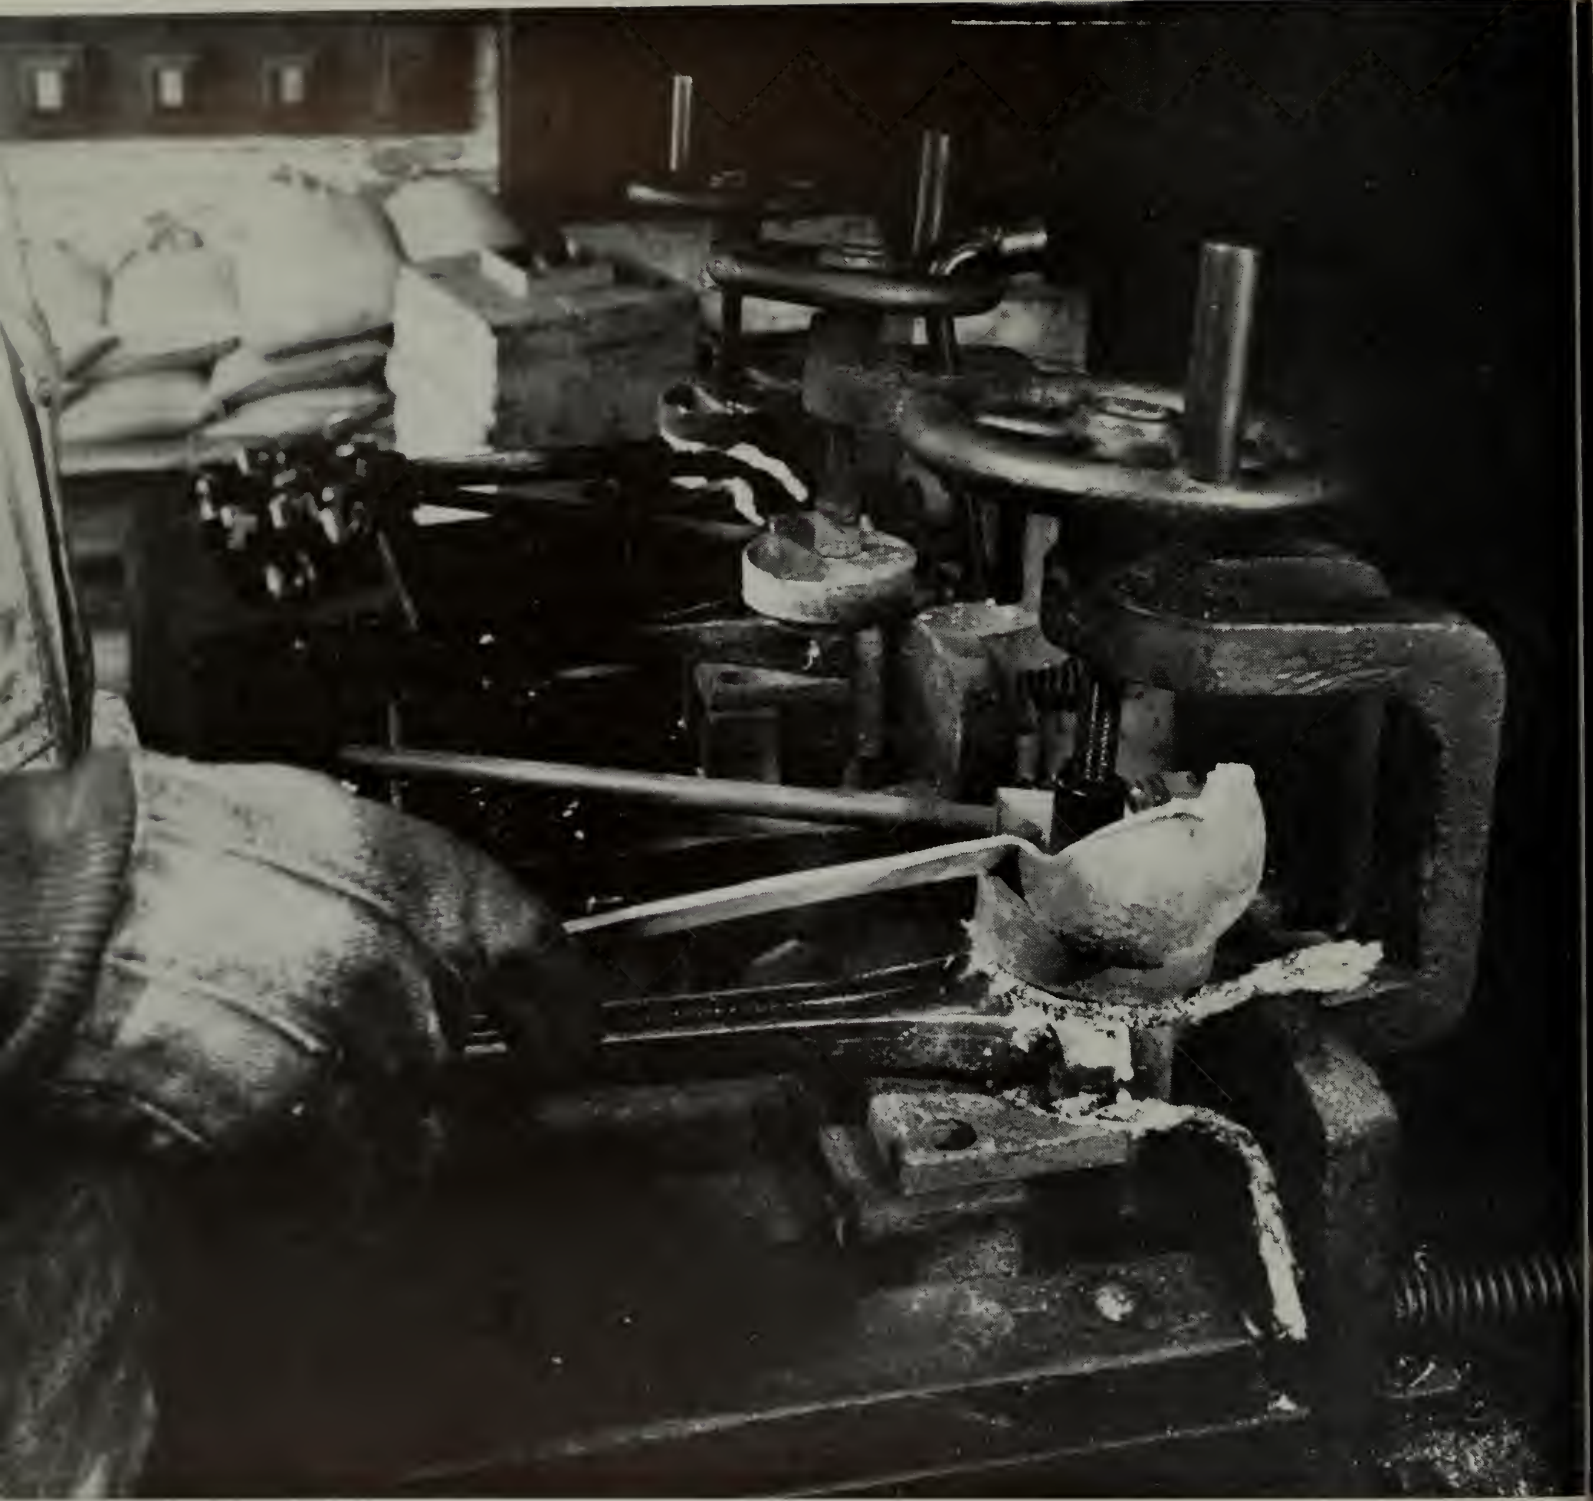
PLAINTIFF'S EXHIBIT No. 12

The mold holder is incased inside a pancake shaped container which is mounted perpendicular to the floor. The center of the door to the container has a hole in it approximately eight inches in diameter. Through this aperture a small trough is affixed as shown above. The small end of the trough leads down into the outer face of the mold which is open. Then when the rod has been set in the mold holder as previously described, the door of the container is closed, and by means of a foot lever the shaft and mold start to revolve spinning the rod with the bearing end as an axis. As the shaft, mold and rod are spun, an operator pours molten babbitt into the trough. The babbitt runs down into the bearing end of the rod and the centrifugal force spreads it evenly over the inside curved surface of the bearing and of the rod.

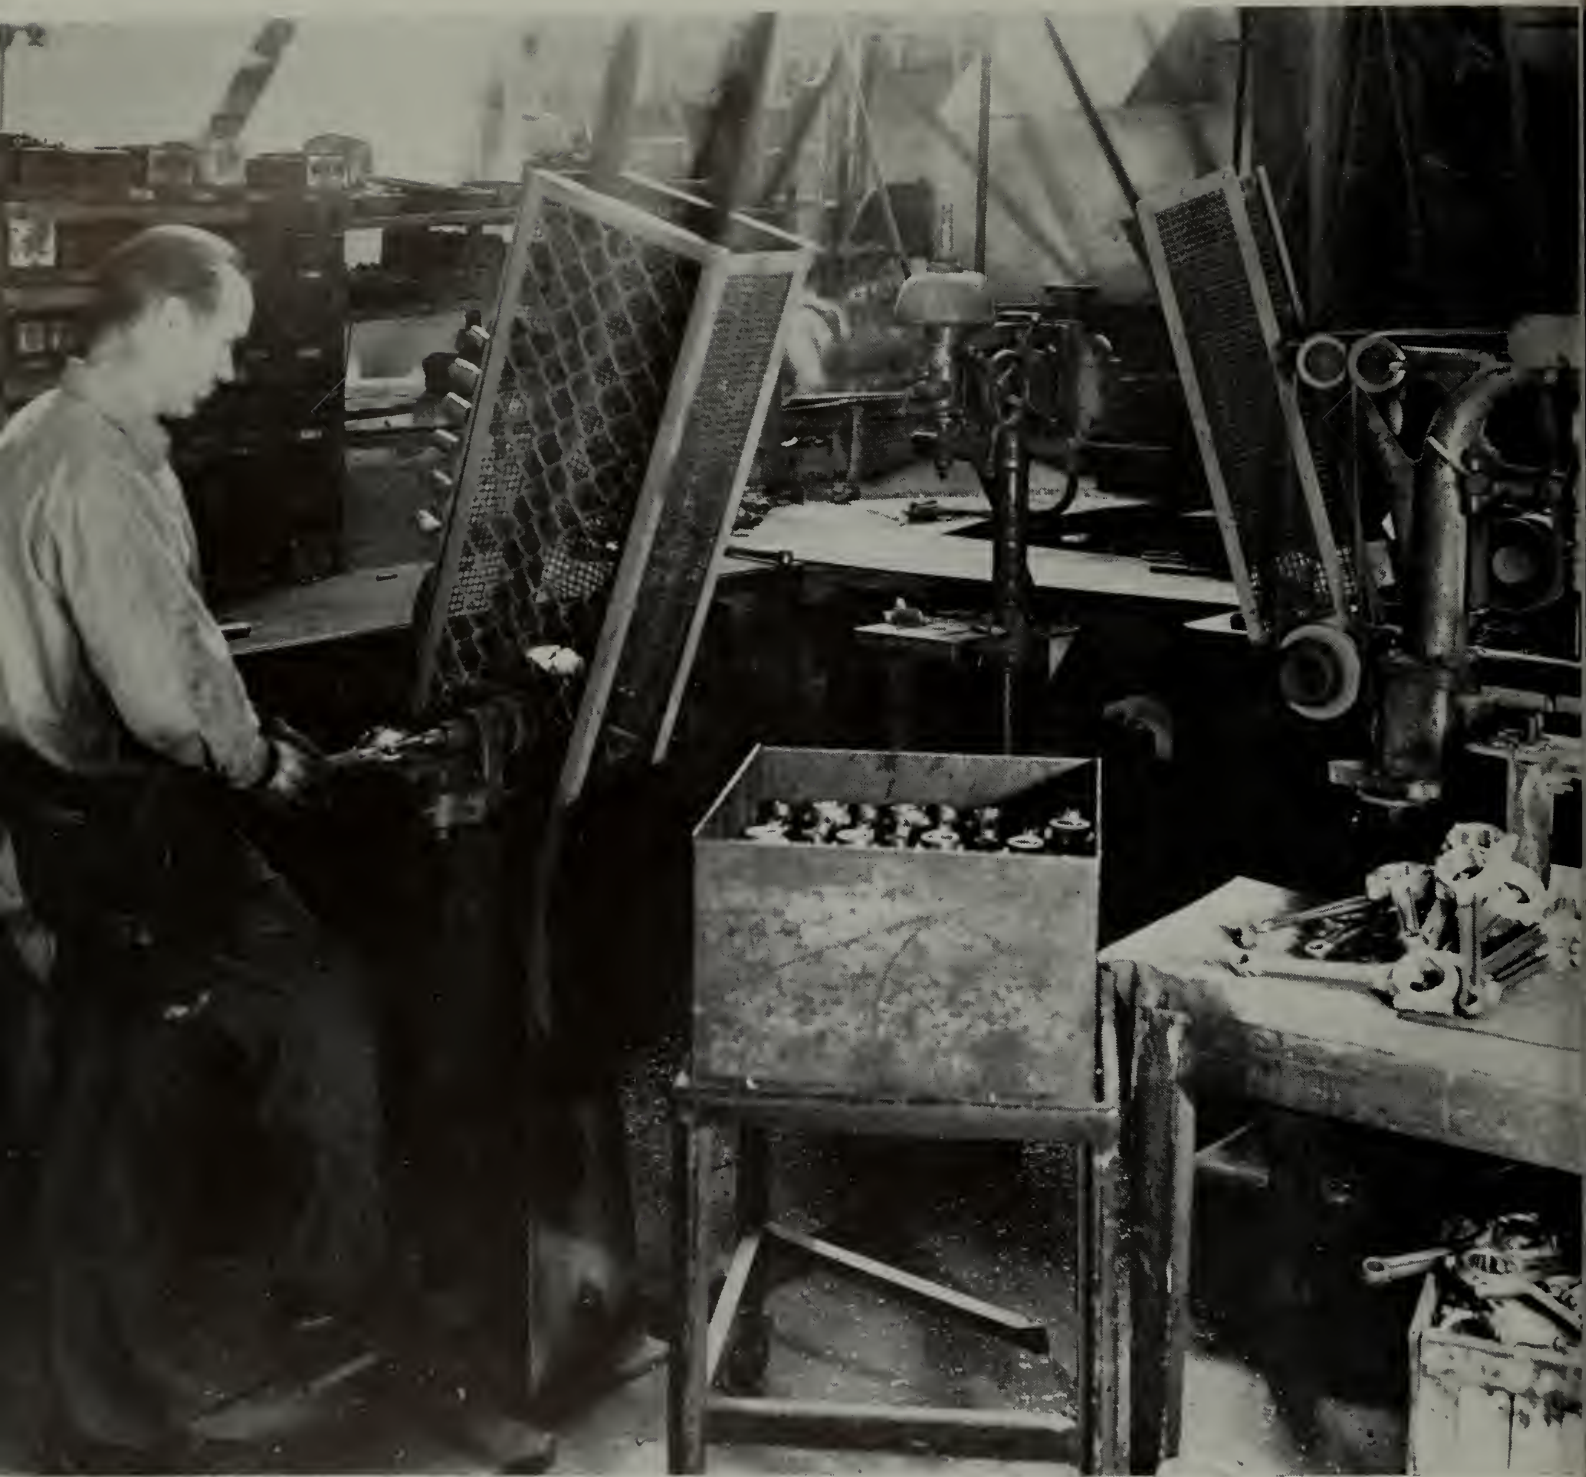
PLAINTIFF'S EXHIBIT No. 16

However, before the cap is fastened to the bearing end of the rod any ragged edges of babbitt which may have adhered where the shims separated the cap from the bearing end of the rod are removed by holding the open face of the cap or the open face of the bearing end of the rod against the revolving sandpaper disc as shown above.

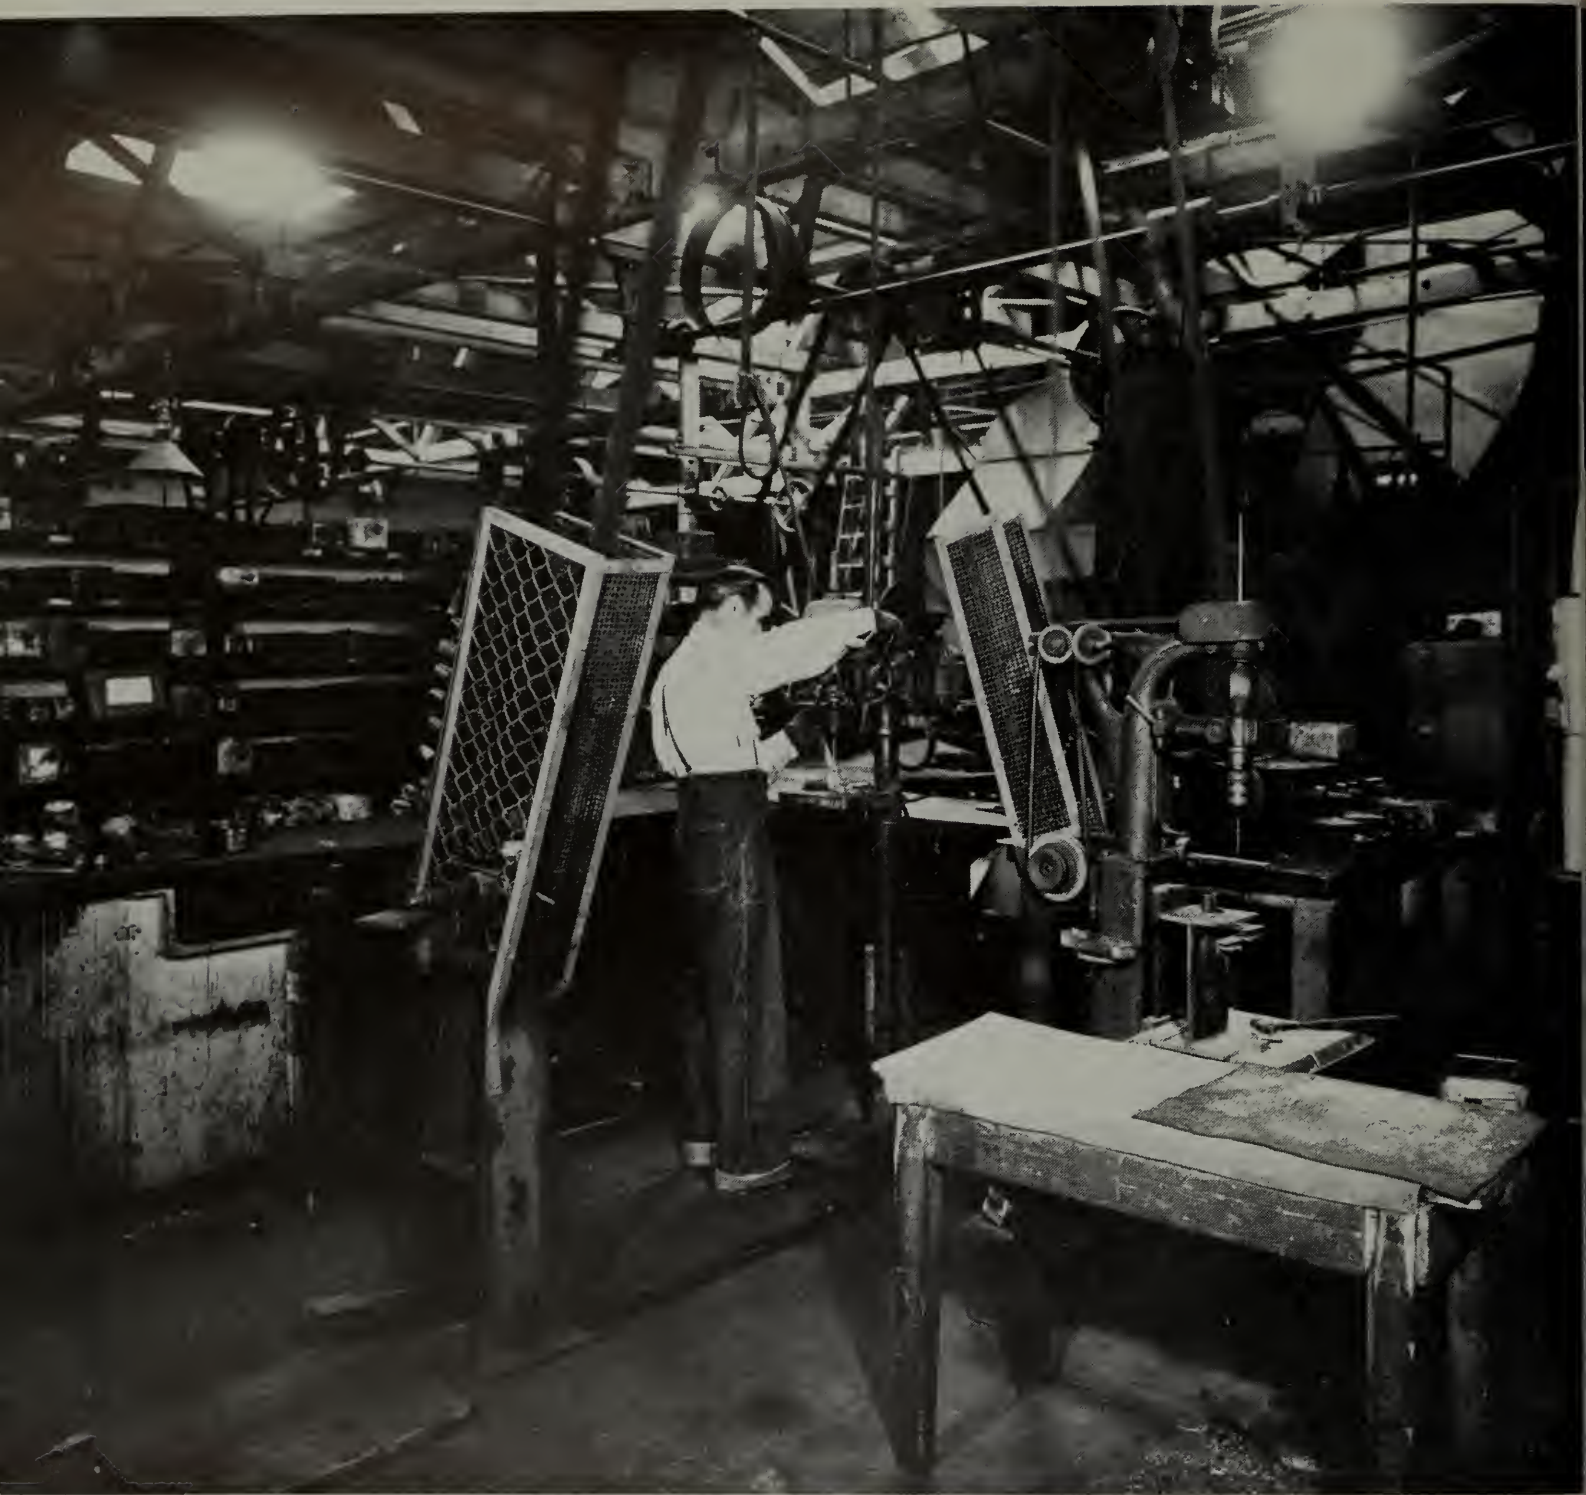
PLAINTIFF'S EXHIBIT No. 17

The cap is replaced on the rod using the original bolts and nuts, the removal of which was described in Picture 5. A power driven socket wrench is used in performing this operation.

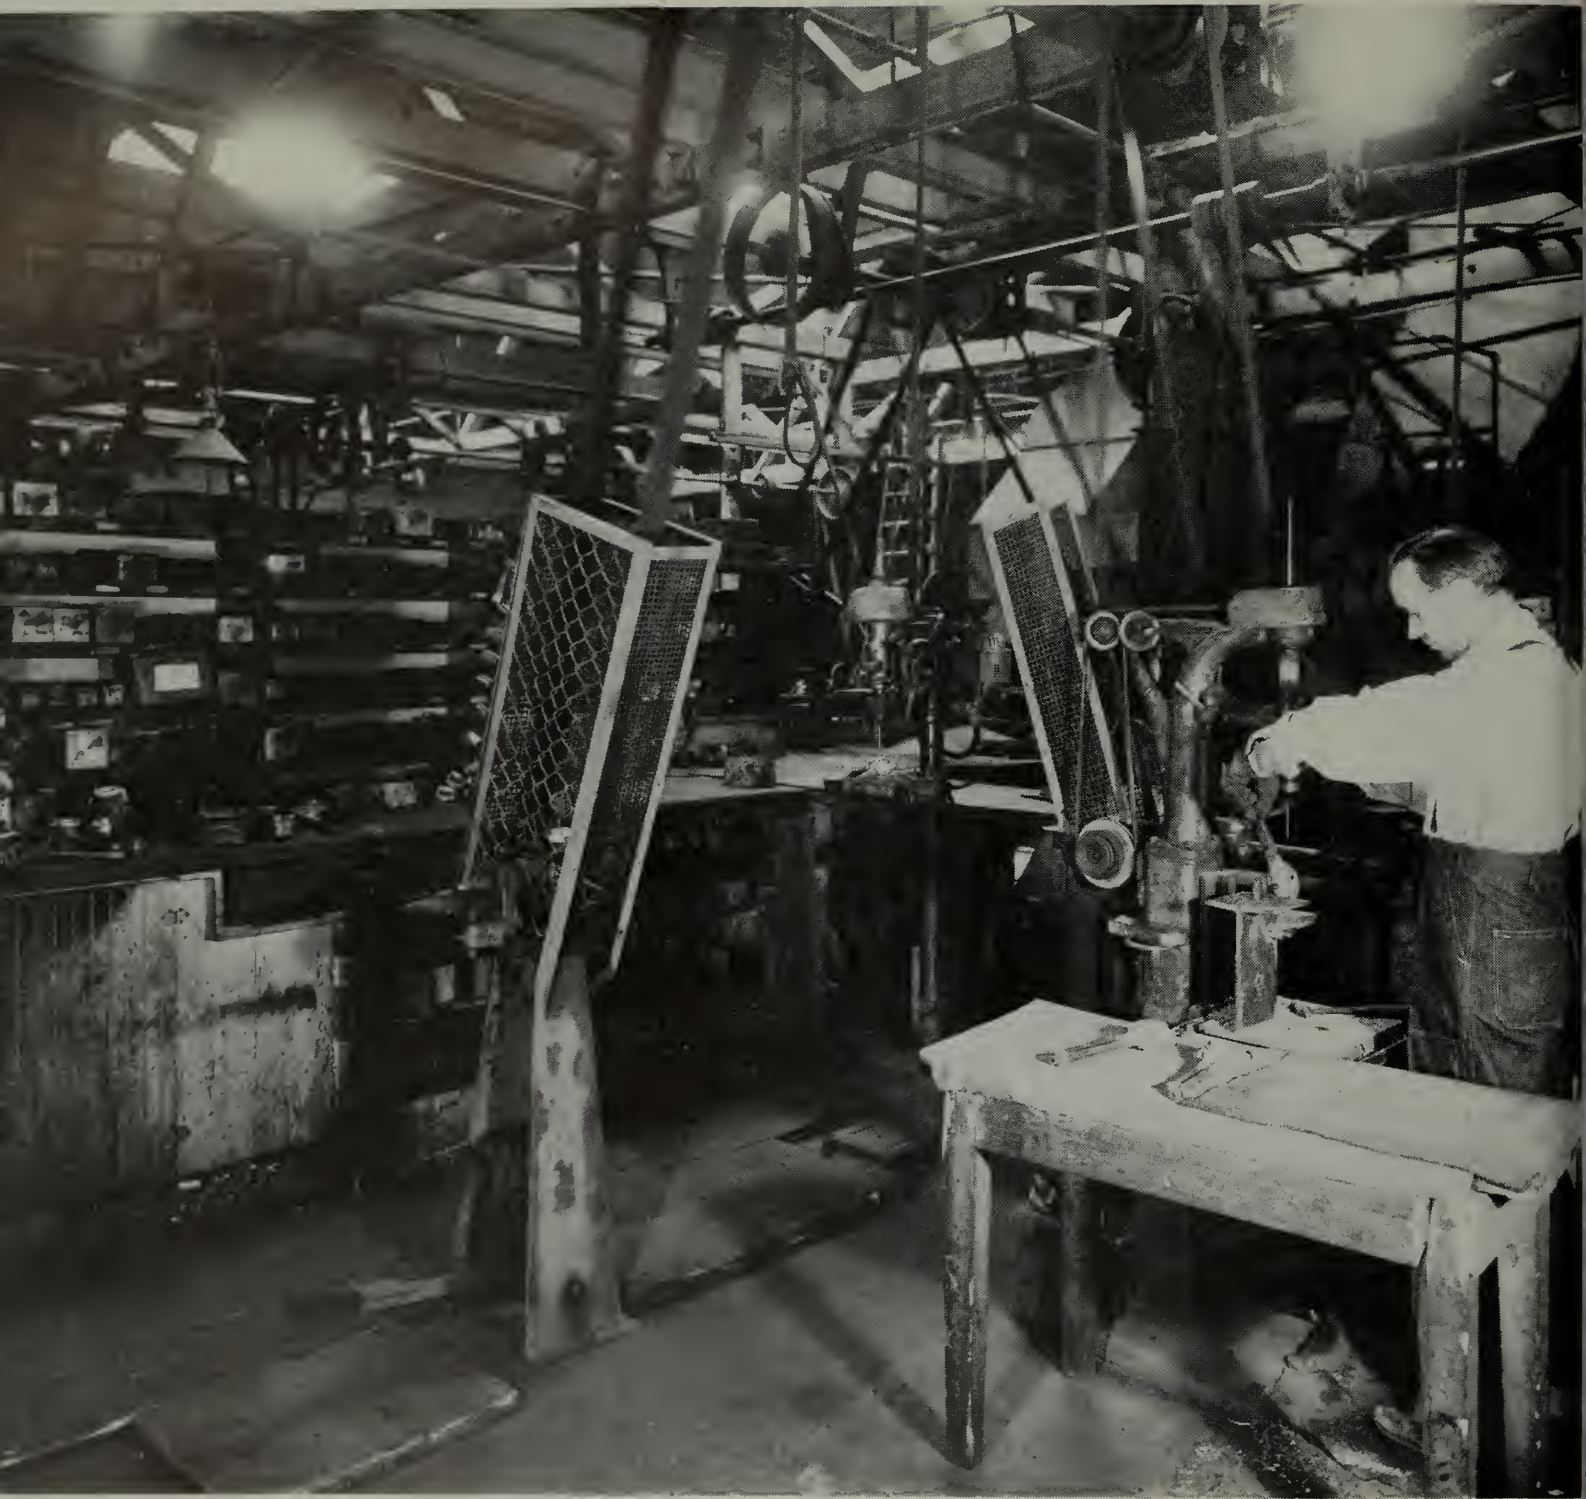
PLAINTIFF'S EXHIBIT No. 18

The operator cleans out the oil holes by use of a drill press as shown in this picture.

The oil holes are not always the same size. Accordingly, the operator uses a second drill press with a larger drill to perform the same operation shown in Picture 18. This removes the necessity for frequently changing drills.

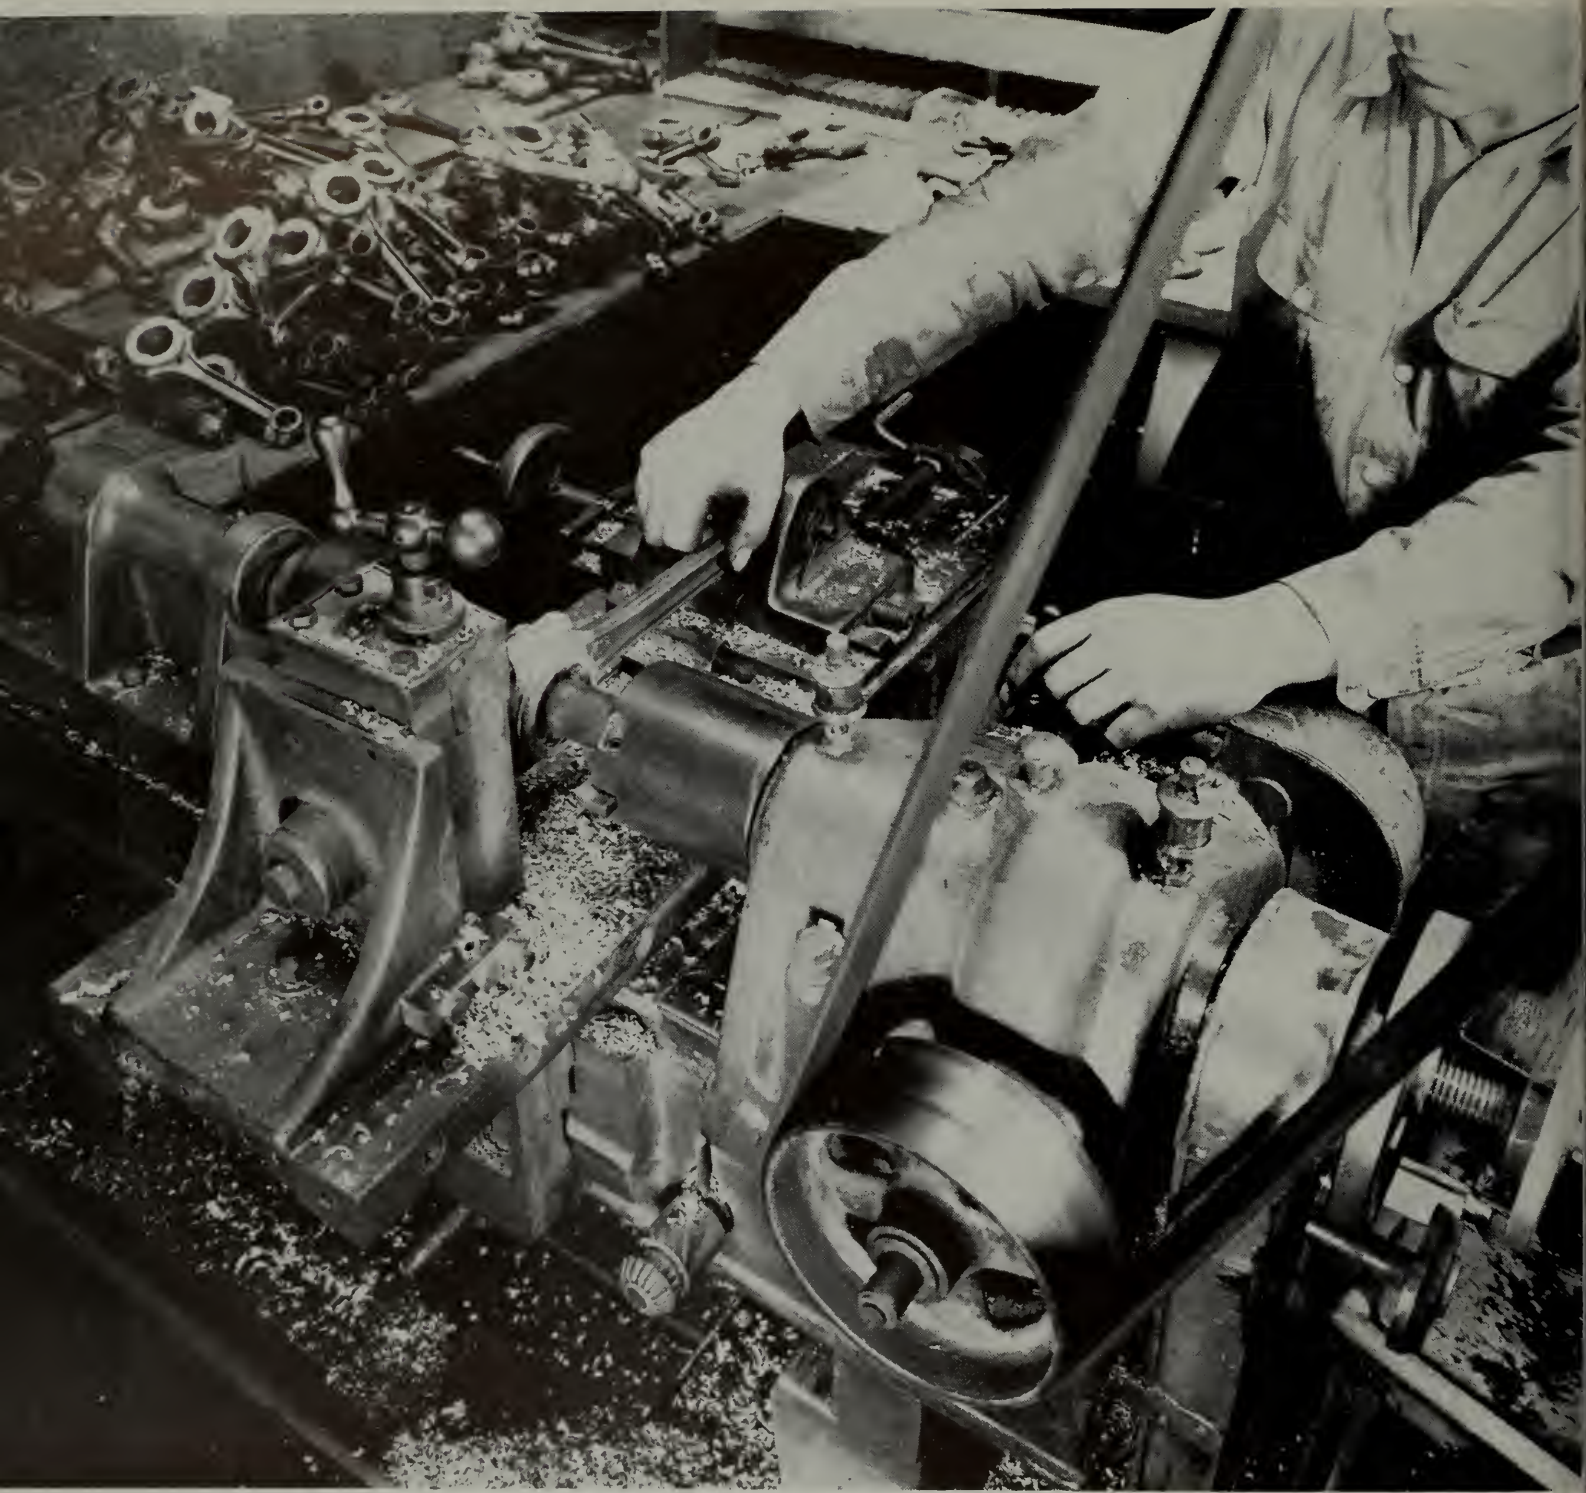
PLAINTIFF'S EXHIBIT No. 20

The rods are now dipped in a rust preventative and are then hung on a rack to dry,—as shown in above picture.

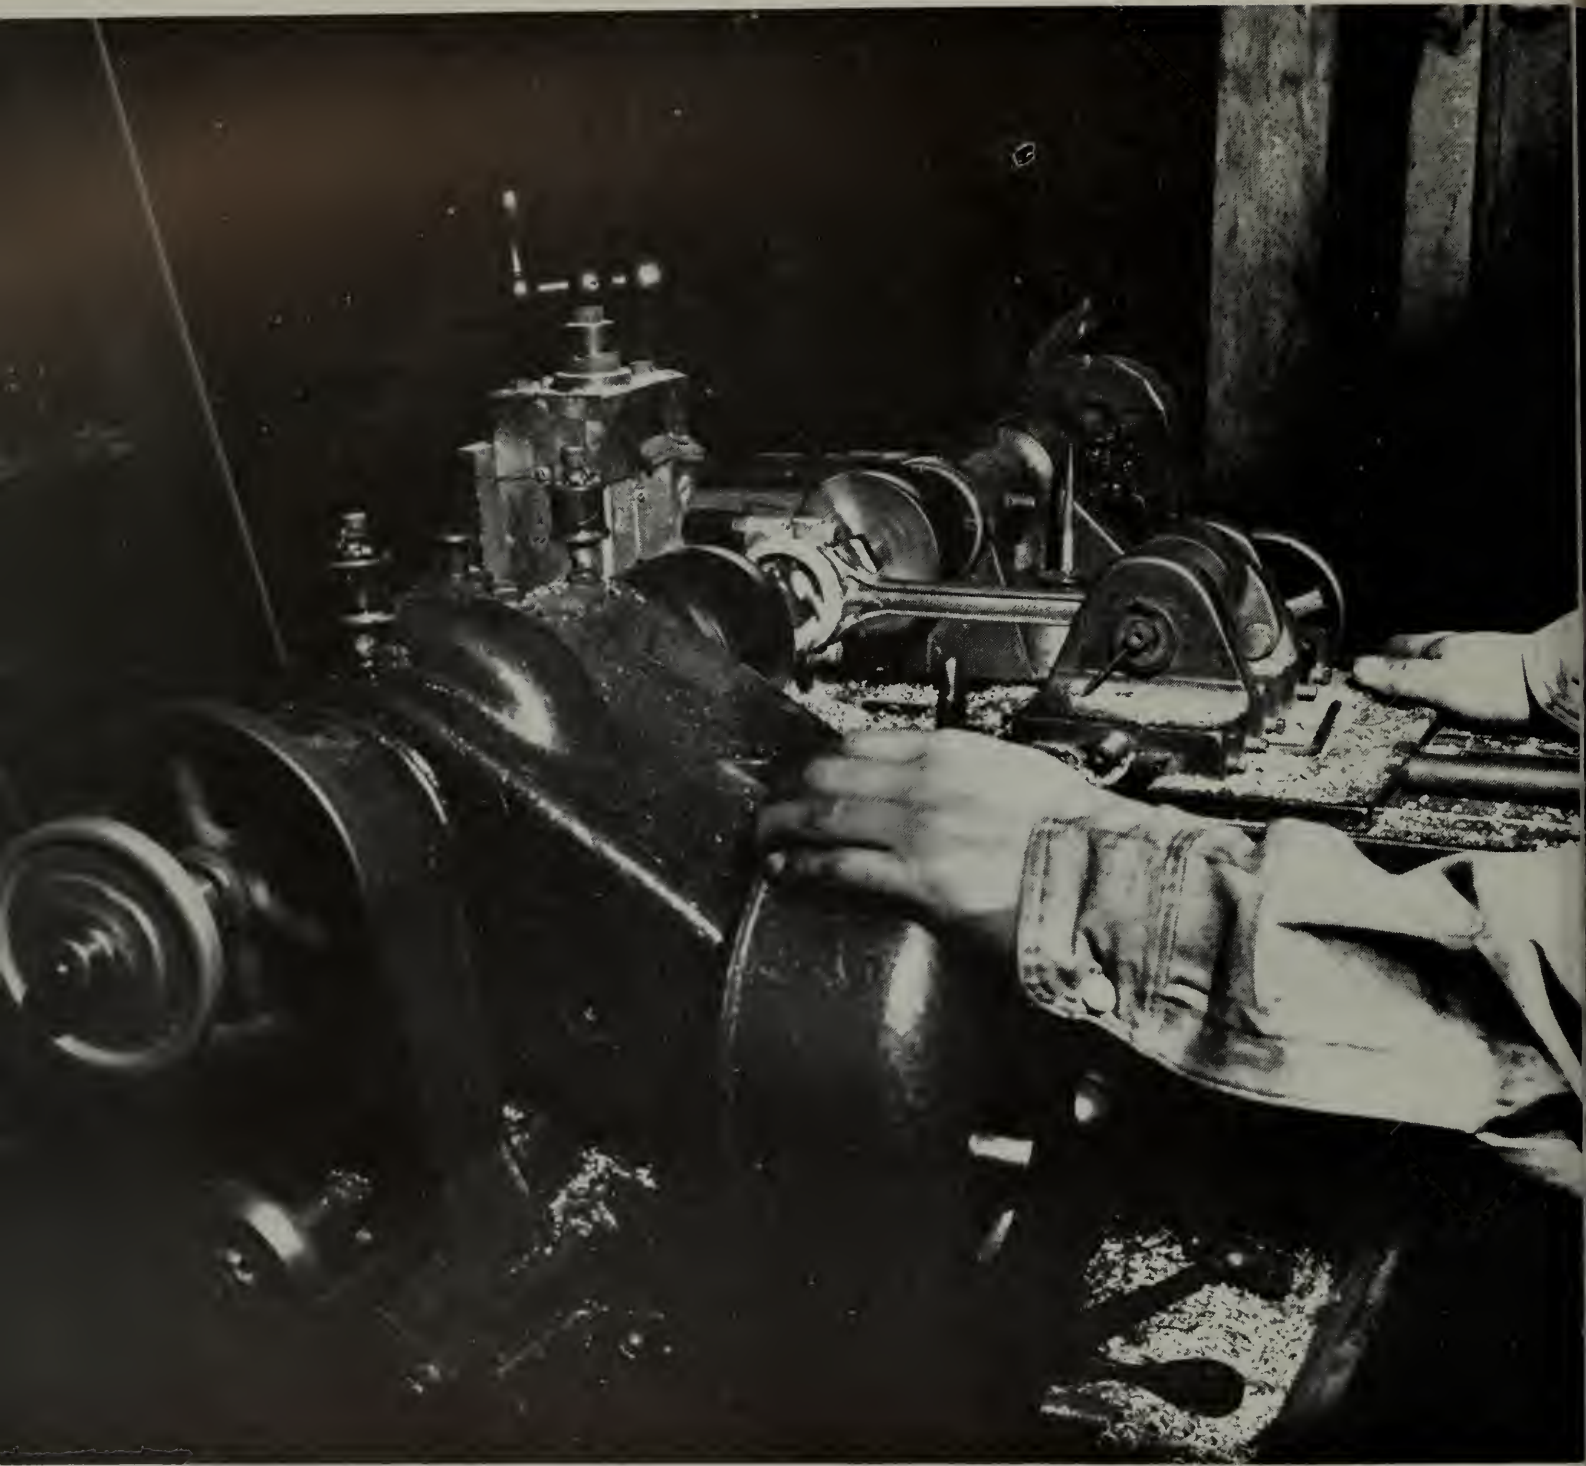
PLAINTIFF'S EXHIBIT No. 21

The rod is now placed in a lathe and the babbitt is bored, faced and chamfered. The latter two operations finishes the bearing to standard width.

The lathe used in the above picture is identical with the one shown in Picture 21, however it is used for finishing babbitt bearings to special undersizes as ordered by the customer. About 20% of the connecting rods rebabbitted by the plaintiff are bored to special undersizes for the reason that the crankshafts of the automobiles in which they are to be placed have been reground in order to correct for the wear which has resulted from long operation.

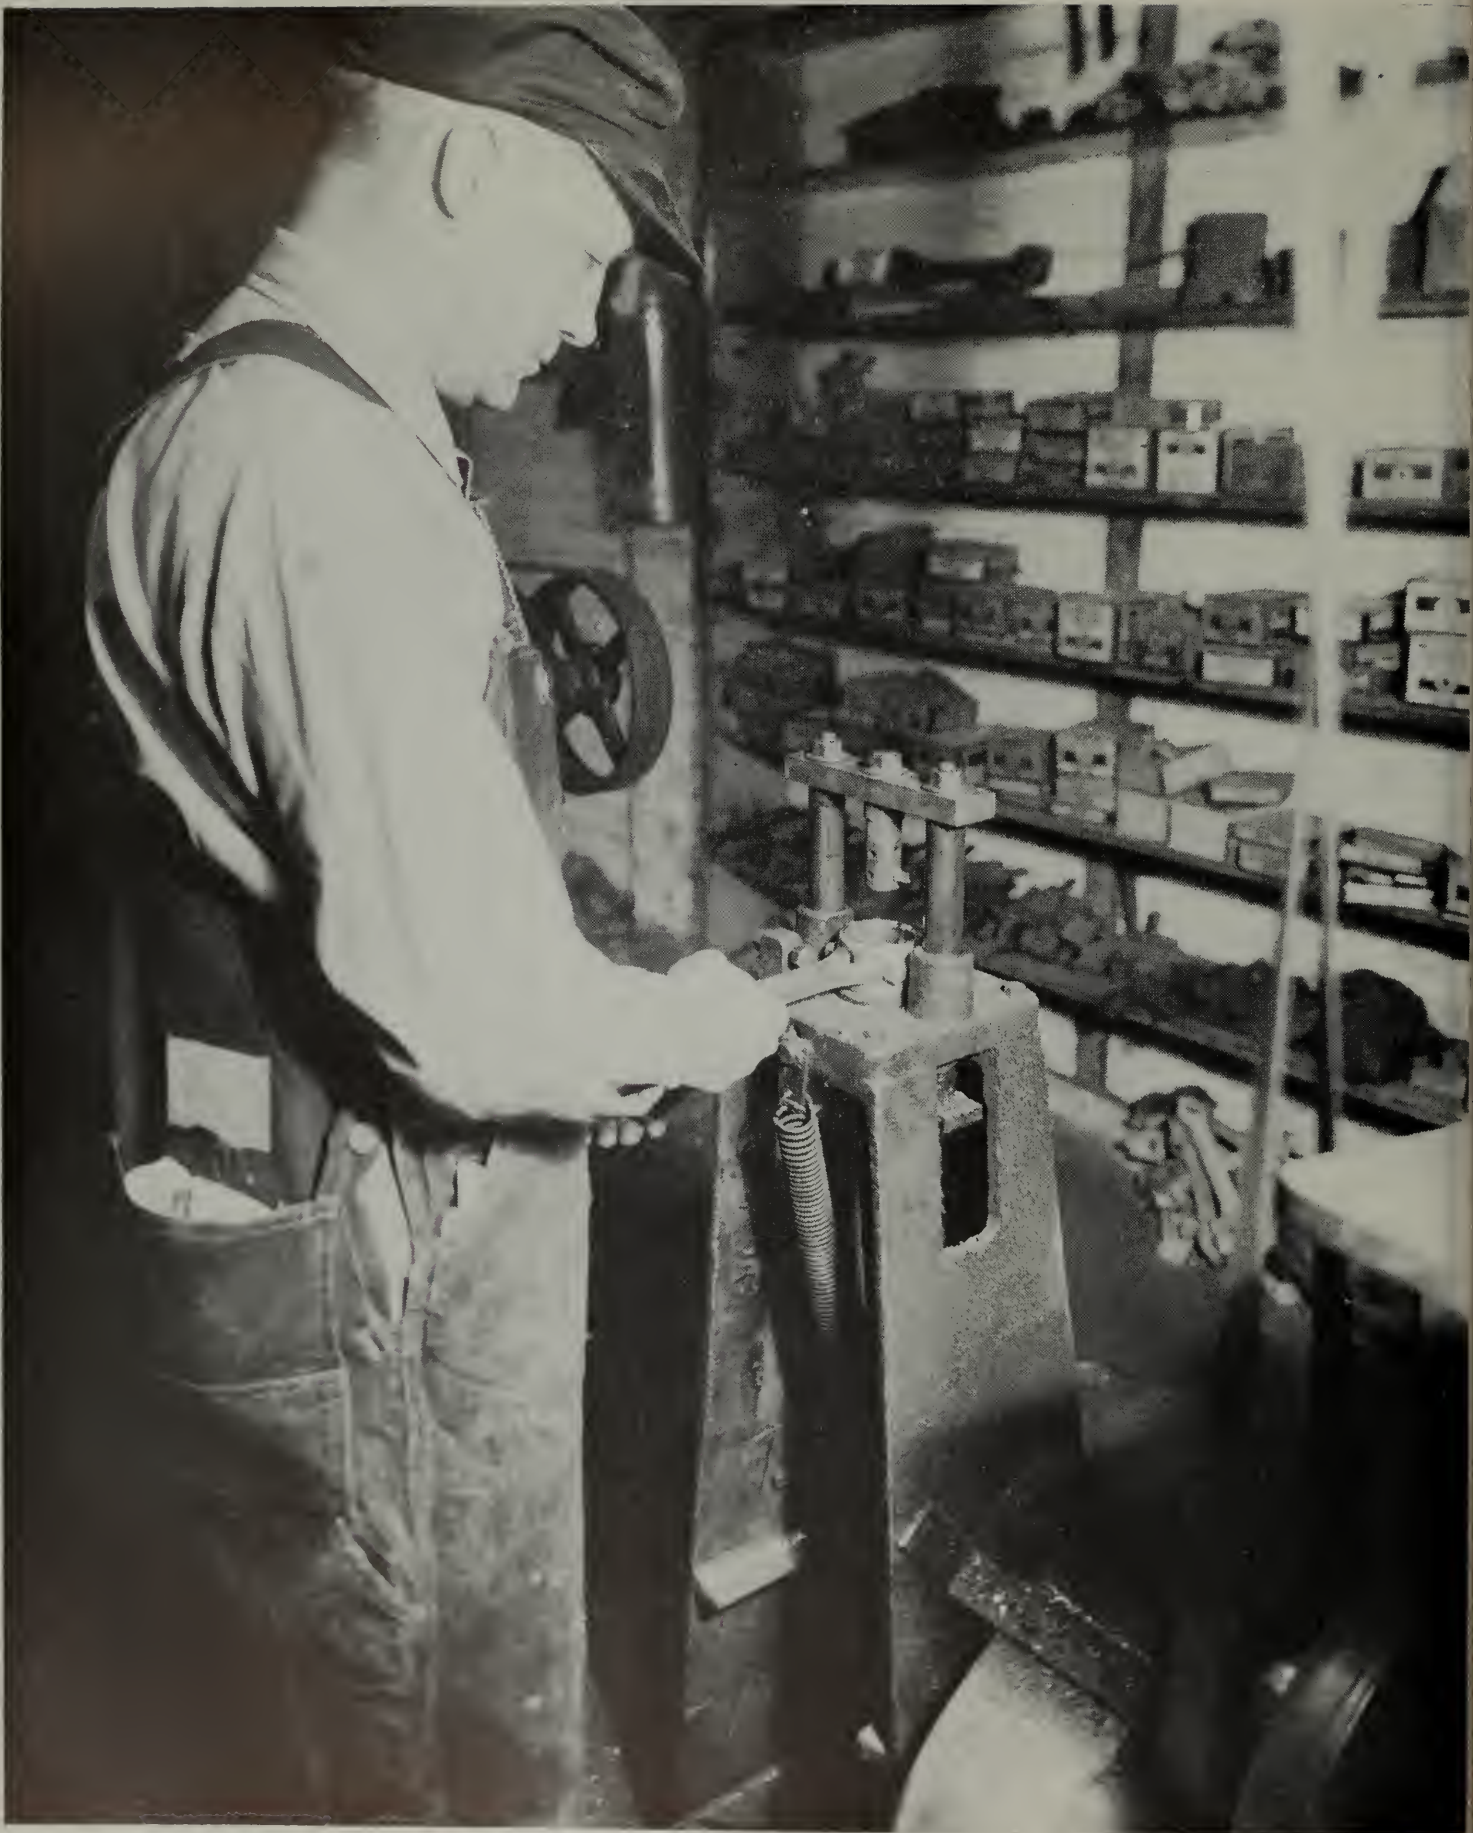
PLAINTIFF'S EXHIBIT No. 23

Approximately fifty per cent of the bearings have oil pockets which are cut by a hand milling machine as shown in the above picture.
